Intel® Pentium® M Processor on 90nm Process with 2-MB L2 Cache

Specification Update

June 2004

Document Number: 302209-002

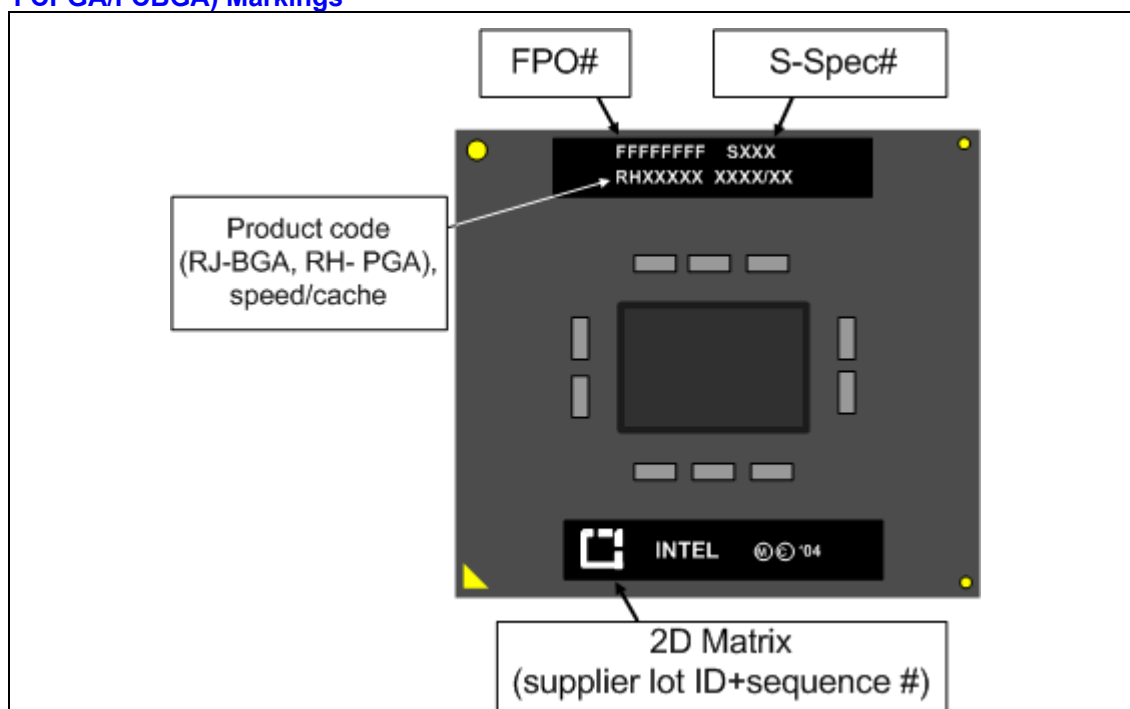
Figure 1. Intel® Pentium® M Processor on 90nm Process with 2-MB L2 Cache (Micro-FCPGA/FCBGA) Markings
